Crew Incapacitation

Investigation Report

Boeing 777-367

B-HNP

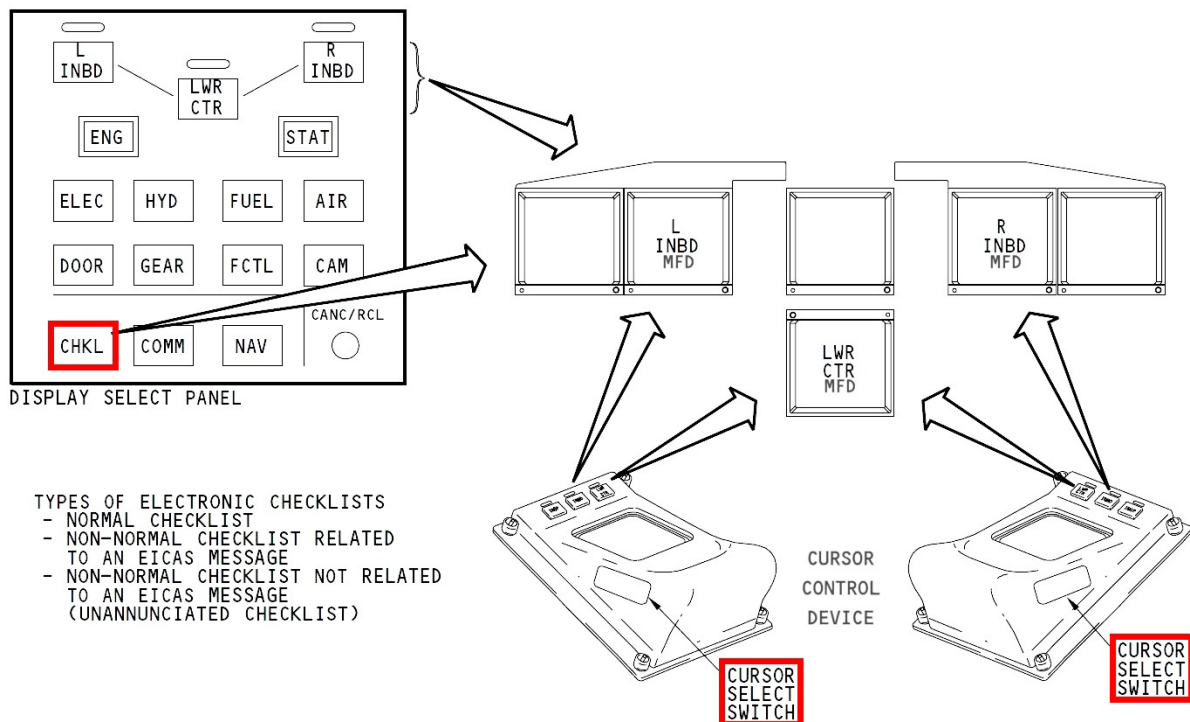
Figure 1: Primary Display System - Electronic Checklist

- (4) The aircraft's autopilot flight director system (AFDS) can automatically control the aircraft attitude through takeoff (flight director only), climb, cruise, descent, approach, go-around, and autoland. It also supplies indications so the flight crew can manually control the aircraft flight trajectory.
- (5) There was no deferred defect or defect log entries on the autopilot system, the VHF system, and the SATCOM⁴ system before the flight.
- (6) Normal and non-normal⁵ electronic checklists (ECL) for aircraft operation can be shown on any multifunction display (MFD) of the Primary Display System. The flight crew completes the electronic checklist item by item on a READ and DO basis.
- (7) Pushing the CHKL switch on the display select panel (DSP) will show a checklist on the selected MFD.
