Crew Incapacitation

Investigation Report

Airbus A350-941

B-LRR

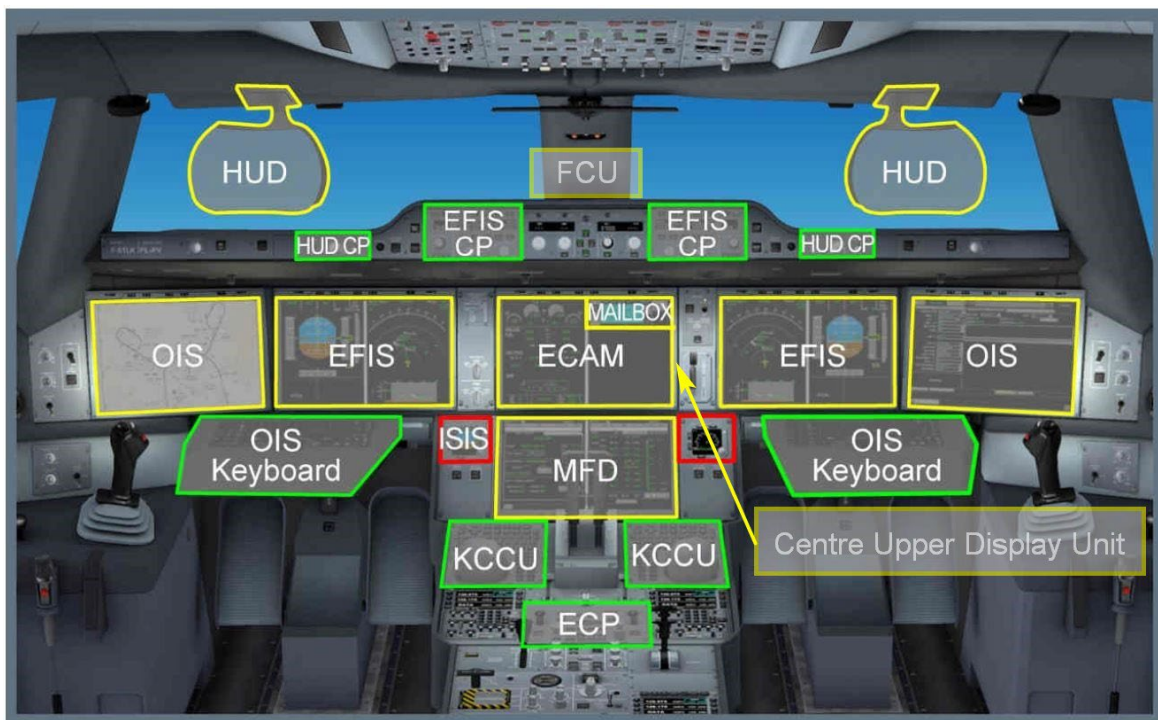
Figure 1: Overview of Control and Display System

ECP - ECAM Control Panel; FCU - Flight Control Unit; KCCU - Keyboard and Cursor Control Unit
